# Taterloch

Tătărlăua / Felsötatárlaka

Alba County

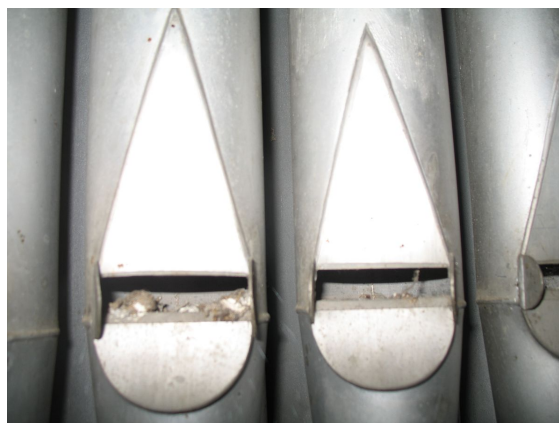
verschmutzt

Unspielbar: Balg kaputt, Pfeifen voller Schutt, schwache Pfeifenqualität im Inneren (Subbafs 16'). / Impracticabil:  
tuburi umplute cu moloz, calitate inferioară a unor tuburi din interior (Subbafs 16').

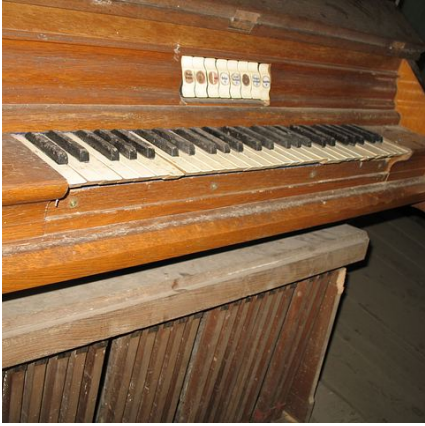
verwahrlost
